Foster Branch Watershed Survey Sediment Source Evaluation

Harford County Department of Public Works
Water Resources Engineering

May 1997

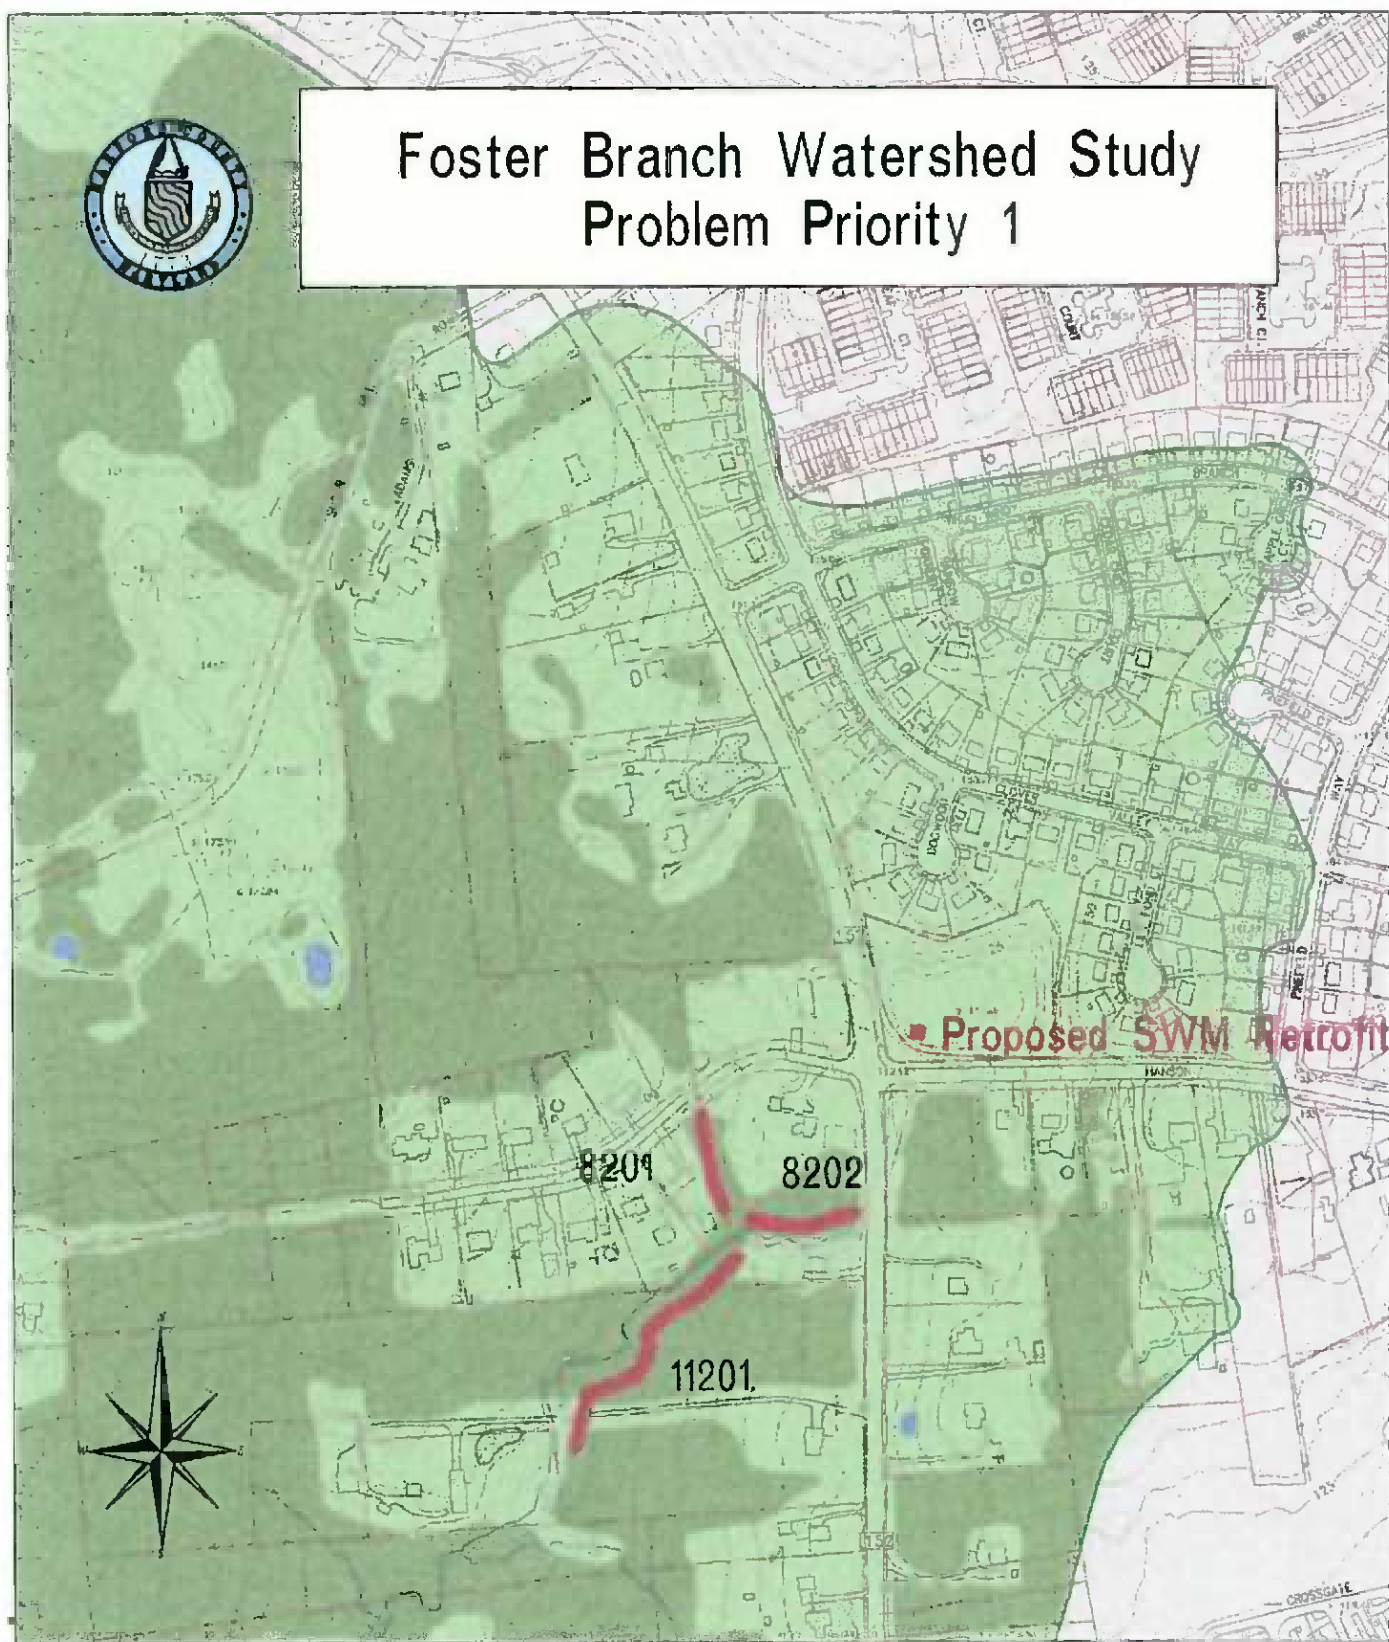
Foster Branch Watershed Study Problem Priority 1

| Site | Rank | Problem | Correction Measure | Cost | Property Owner |
|---|---|---|---|---|--|
| 8202, 8201, 11201 | 1 | Channel downcutting | 1. Increase storage of Woodbridge pond to control 1 year storm 2. Stream restoration | 1. \$75K-\$100K 2. \$103K-\$225K | 1. Woodbridge HOA 2. R. Comp, H. Ryan, A. Phillips, S. Semenuk |

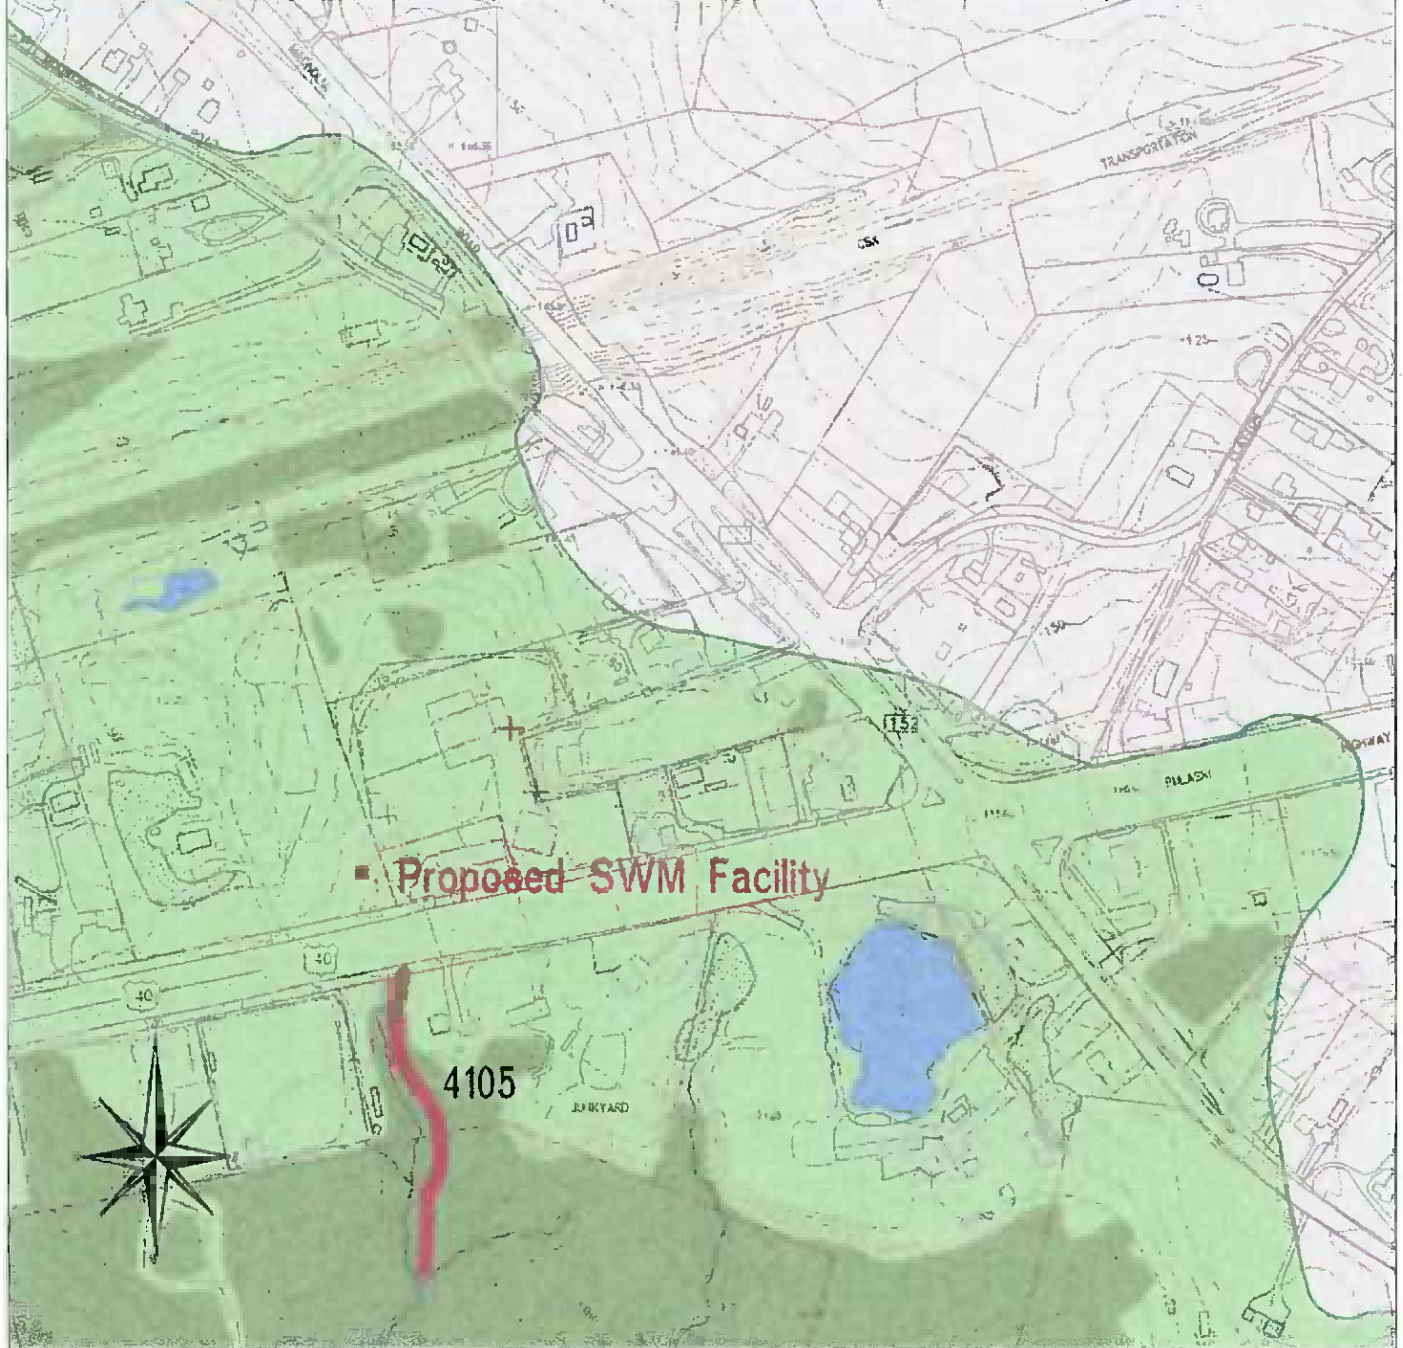
Foster Branch Watershed Study Problem Priority 2

| Site | Rank | Problem | Correction Measure | Cost | Property Owner |
|---|---|---|---|---|--|
| 4105 | 2 | Channel downcutting | 1. New SWM facility upstream of Rt 40 2. Stream restoration to Class B channel | 1. \$75K-85K 2. \$168K-\$360K | 1. CSP Assoc., L. Day 2. C. Fruhling, Oak Grove Baptist |

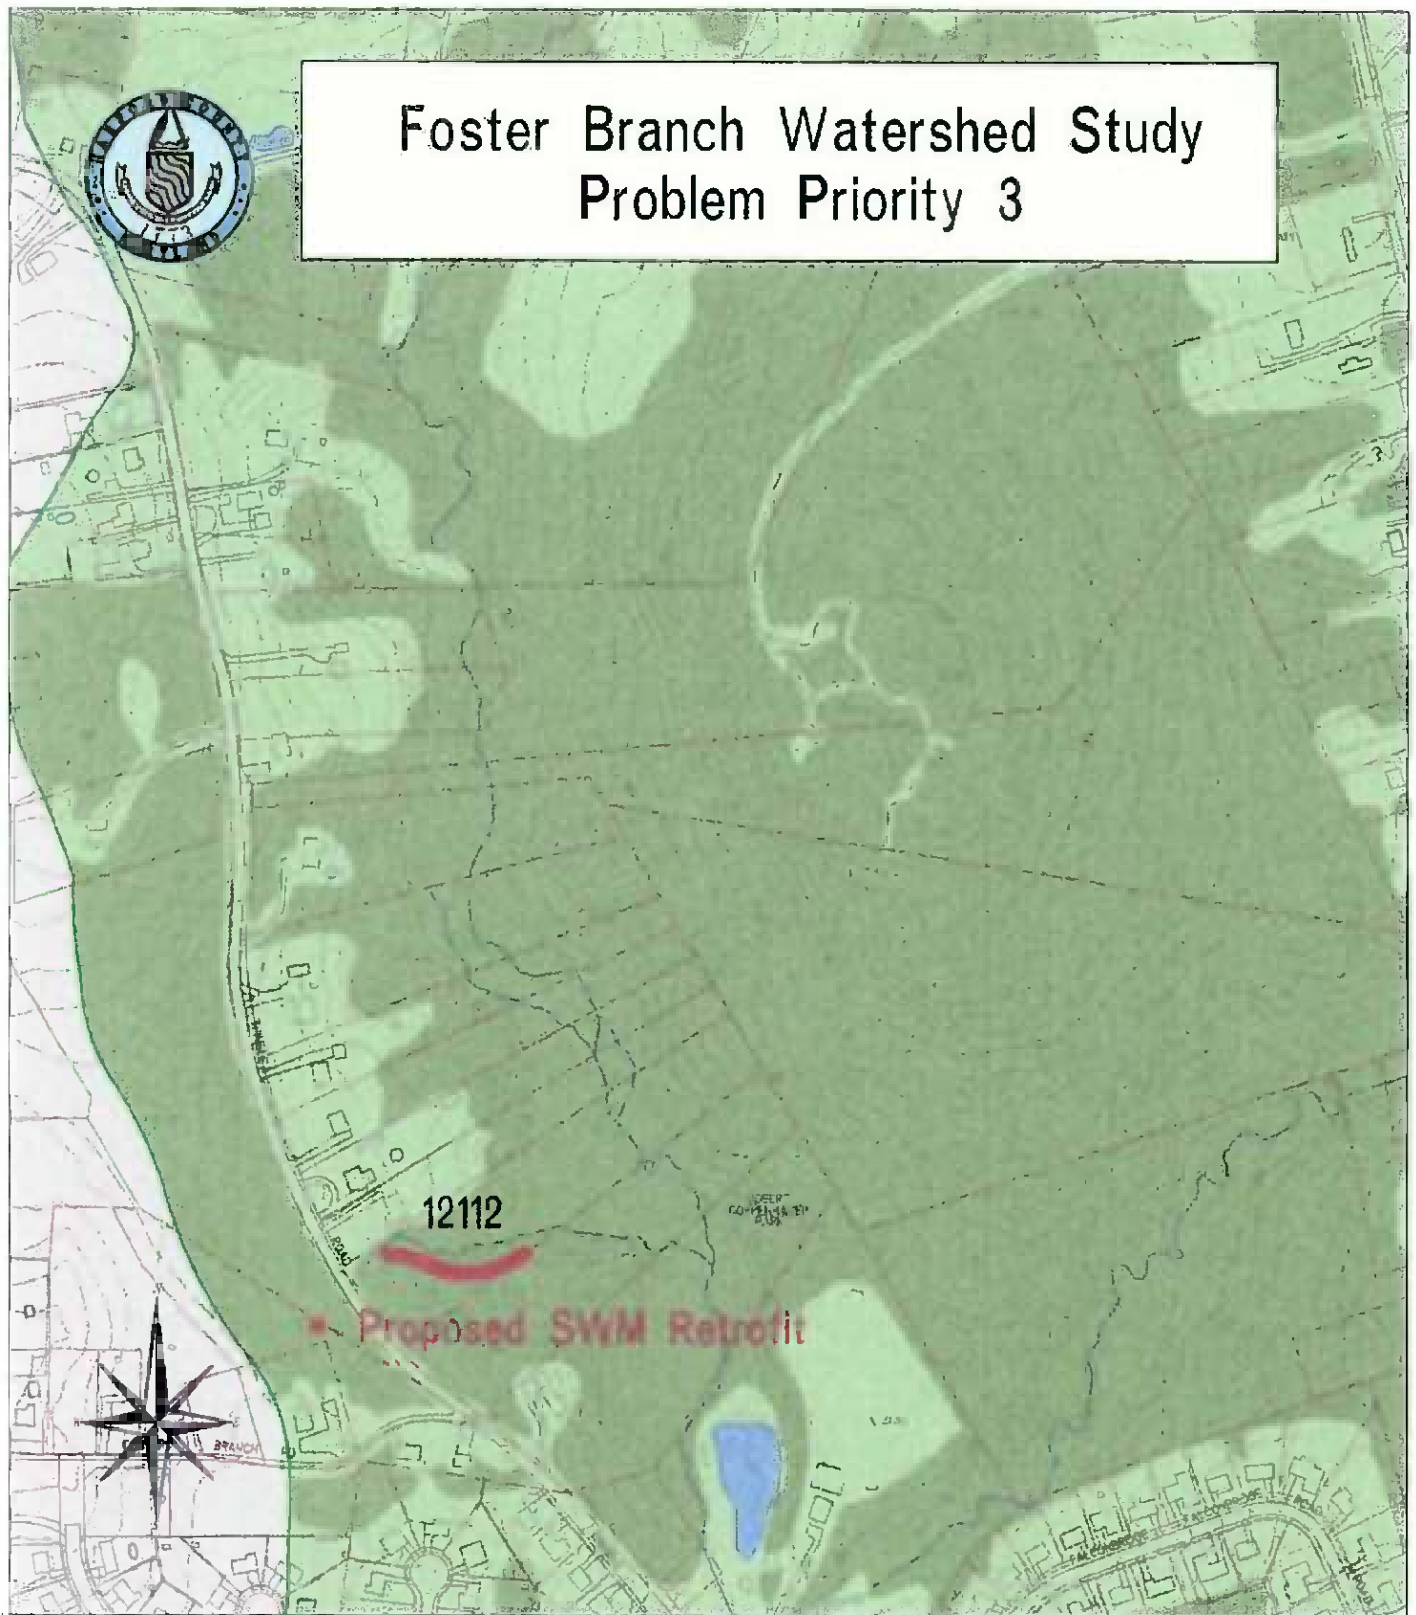
Foster Branch Watershed Study Problem Priority 3

| Site | Rank | Problem | Correction Measure | Cost | Property Owner |
|---|---|---|---|---|--|
| 12112 | 3 | Channel downcutting | 1. Retrofit SWM facility at Joppa Woods to control 1 year storm 2. Stream restoration to Class B channel | 1. \$35K-\$50K 2. \$101K-\$216K | 1. Suburban Homes, Inc. 2. R. Martin, E. Starkey, H. Duckworth |

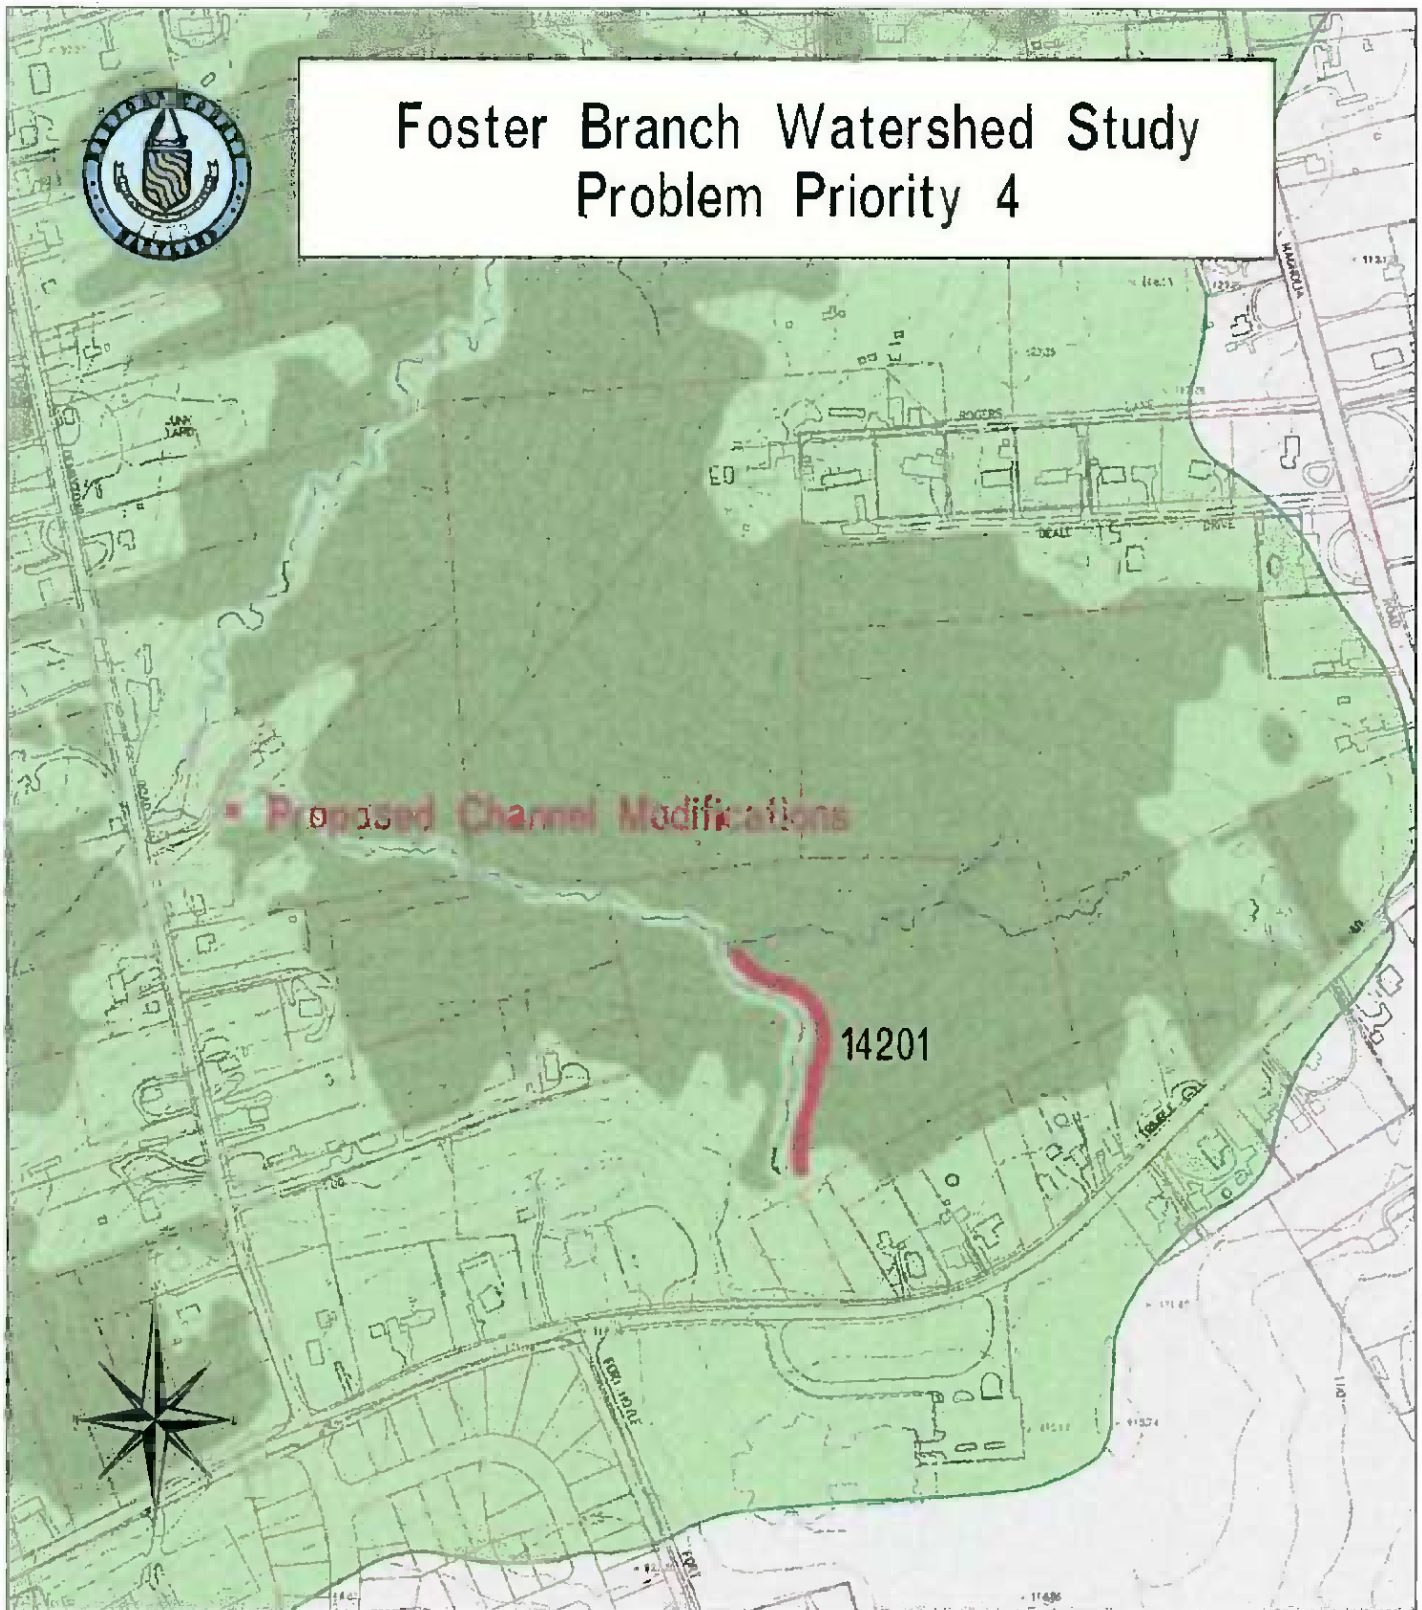
Foster Branch Watershed Study Problem Priority 4

| Site | Rank | Problem | Correction Measure | Cost | Property Owner |
|---|---|---|---|---|--|
| 14201 | 4 | Natural bank erosion | 1. Lay back banks and plant 2. Recreate low flow channel east of Dembytown Rd | 1. \$30K 2. \$34K-\$72K | 1. Church @ Joppa, Inc. 2. A. Downing, J. Gilbert |

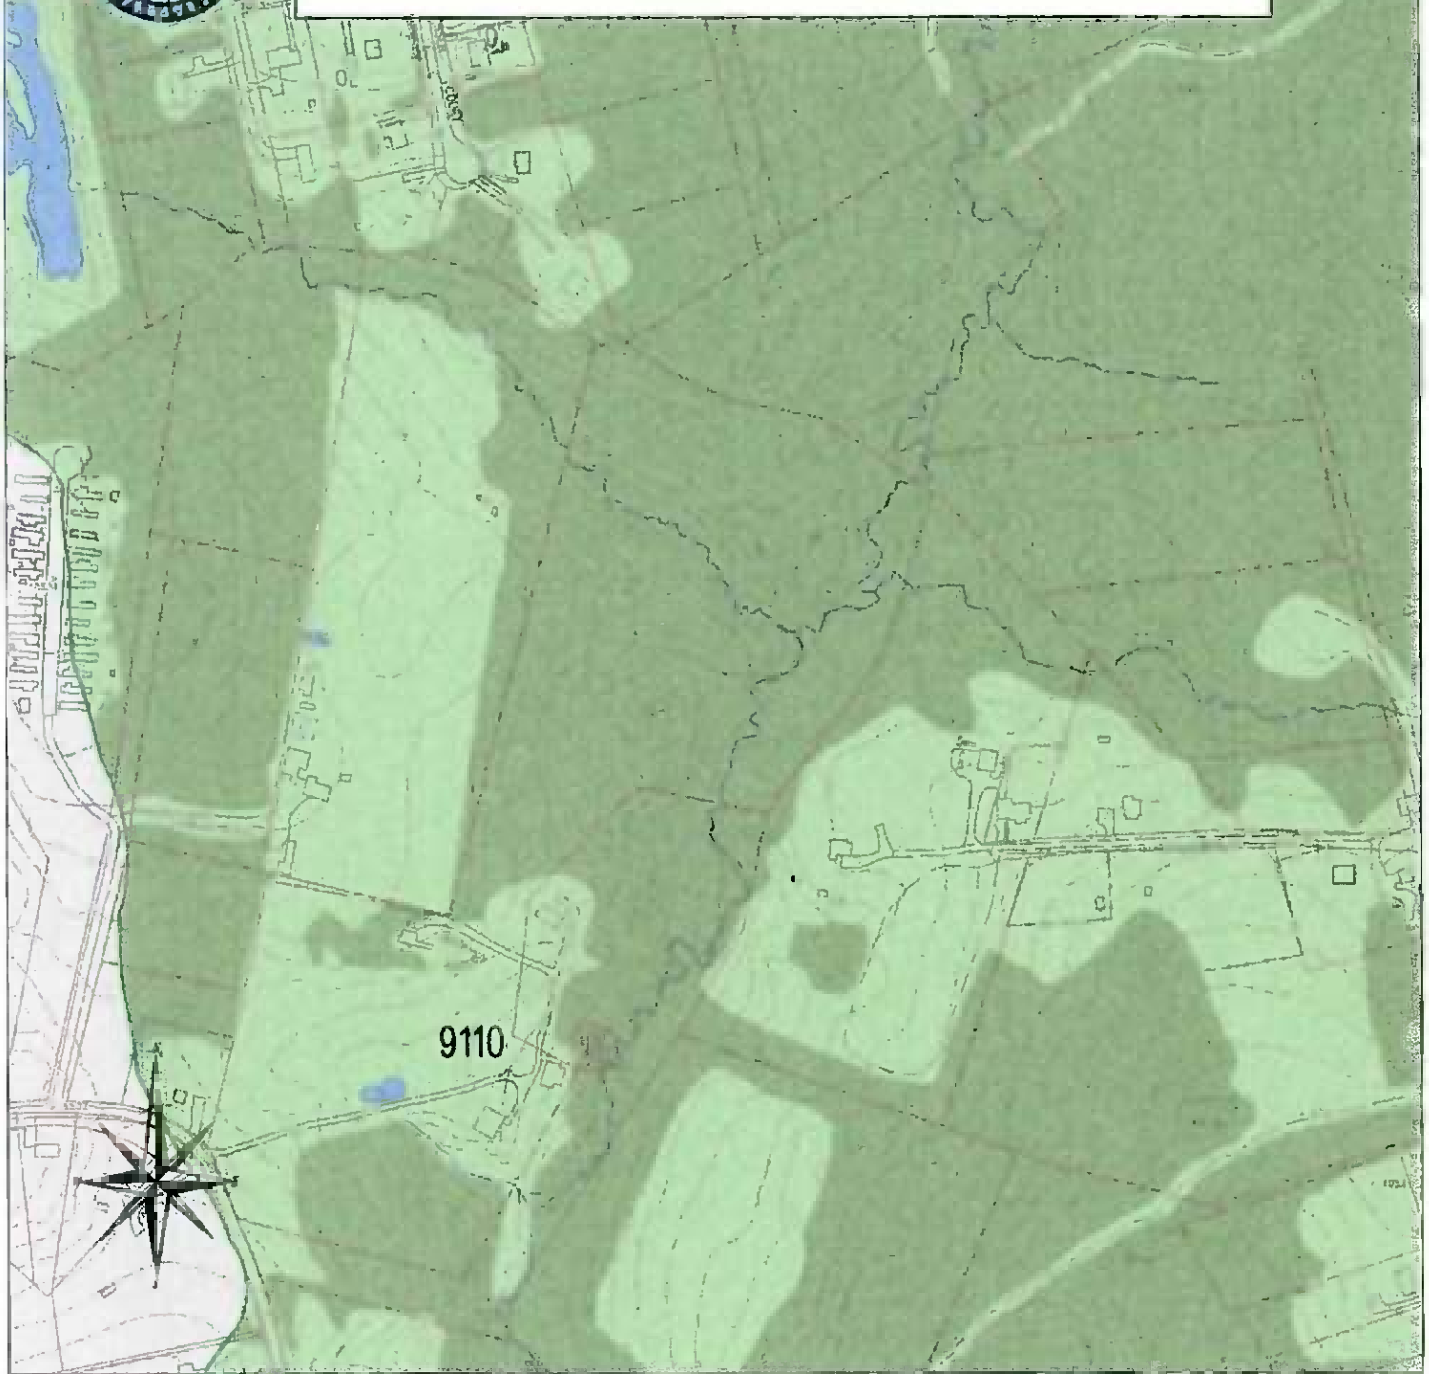
Foster Branch Watershed Study Problem Priority 5

| Site | Rank | Problem | Correction Measure | Cost | Property Owner |
|---|---|---|---|---|--|
| 9110 | 5 | Drainage channel headcut | 1. Redirect and spread roof runoff from barn. 2. Stabilize channel with rock vortex weirs | \$1K | J. Williams. |

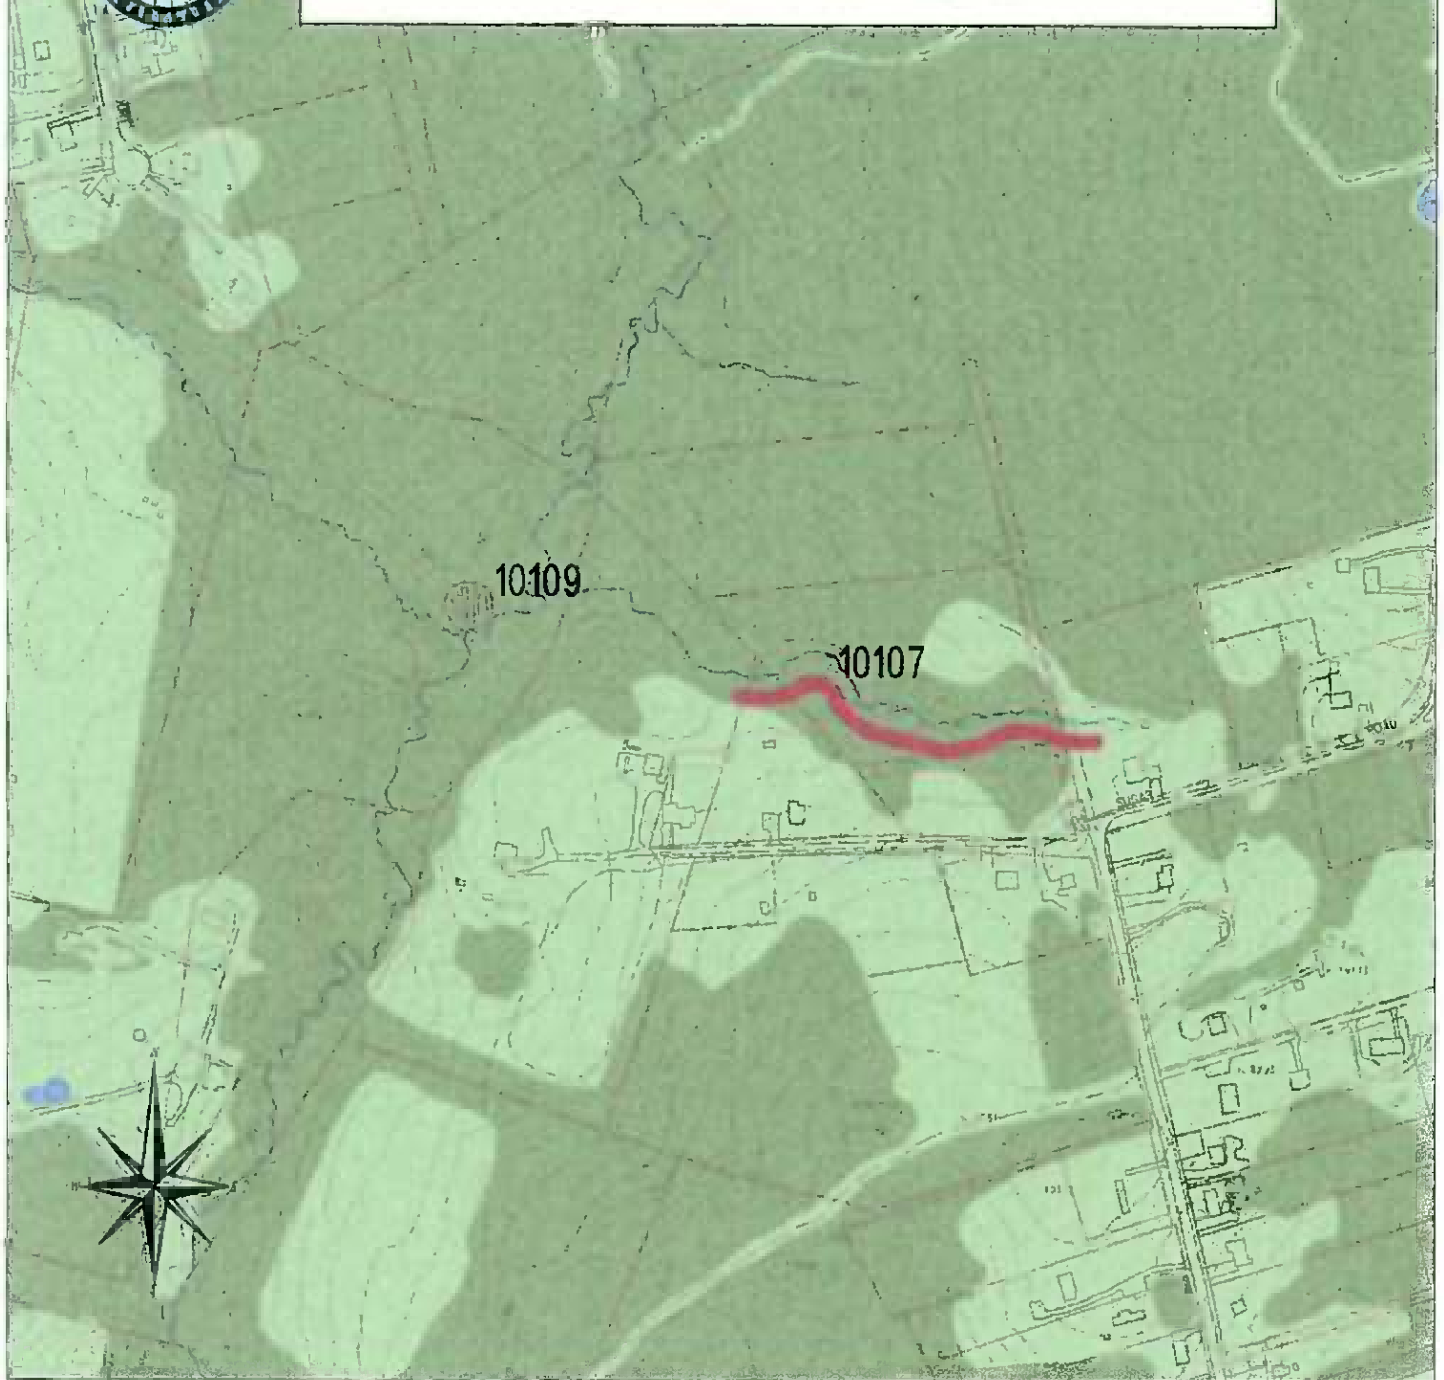
Foster Branch Watershed Study Problem Priority 6

| Site | Rank | Problem | Correction Measure | Cost | Property Owner |
|---|---|---|---|---|--|
| 10107, 10109 | 6 | Trash and woody debris in stream redirecting flow | 1. Remove debris | \$5K | R. Williams, R. Hoffman, D. Matesic |
